## **Bayside Planning Panel**

Item No	5.3
Application Type	Development Application
Application Number	DA-1997/49/F
Lodgement Date	3 August 2017
Property	<b>339-377 Forest Road, Bexley</b>
Owner	Coptic Orthodox Church (NSW) Property Trust
Applicant	Mr Talaat Nasralla
Proposal	Proposal to remove ten (10) trees within the site
No. of Submissions	Two(2) letters of objection and one(1) petition (57 signatures)
Cost of Development	N/A – S96
Report by	Helen Lai, Student Town Planner Marta Gonzalez-Valdes, Coordinator Major Assessments

## Section 96(1A) – Delegated Report

### St Mary & St Mina's Coptic Orthodox Cathedral and College

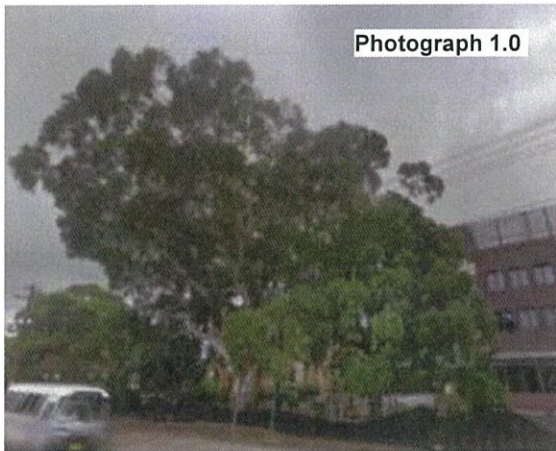
**Photograph 1.0** View to north of Tree 1 (center) *Eucalyptus globulus* – Southern Blue Gum, showing crown projection over street, proximity to boundary and foot path in street.

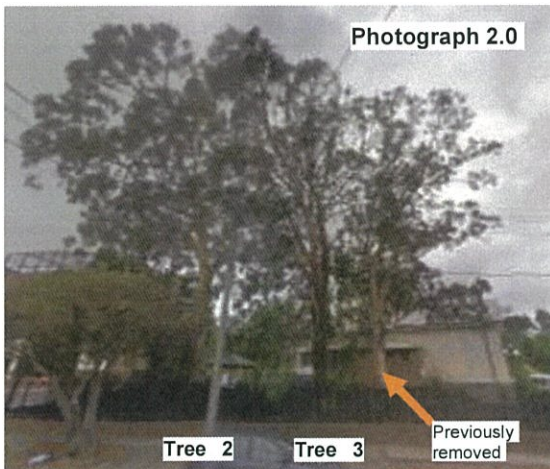
**Photograph 2.0** View to north of Trees 2 and 3 *Eucalyptus globulus* – Southern Blue Gum, showing crown projection over street, proximity to boundary, damaged retaining wall and foot path in street.

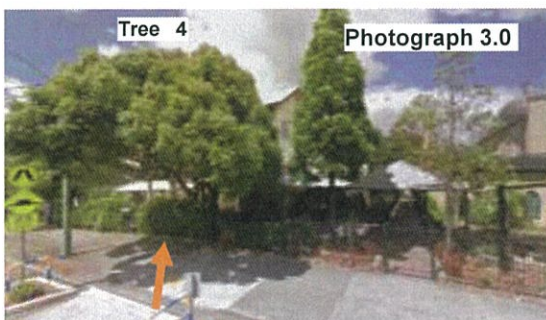
4	Environmental weed species. Growing 1 m from property boundary and foot path within street with a first order root to southeast 200 mm diameter disrupting the pavement in the street creating trip hazards. Pruning the roots is not acceptable as the tree may become unstable or be weakened by decay pathogens entering the wounds affecting structural roots and trunk.

**Photograph 3.0** View to southwest of Tree 4 *Cinnamomum camphora* – Camphor Laurel, showing crown projection over street, proximity to boundary and foot path in street. Arrow indicates location of disrupted pavement in street.

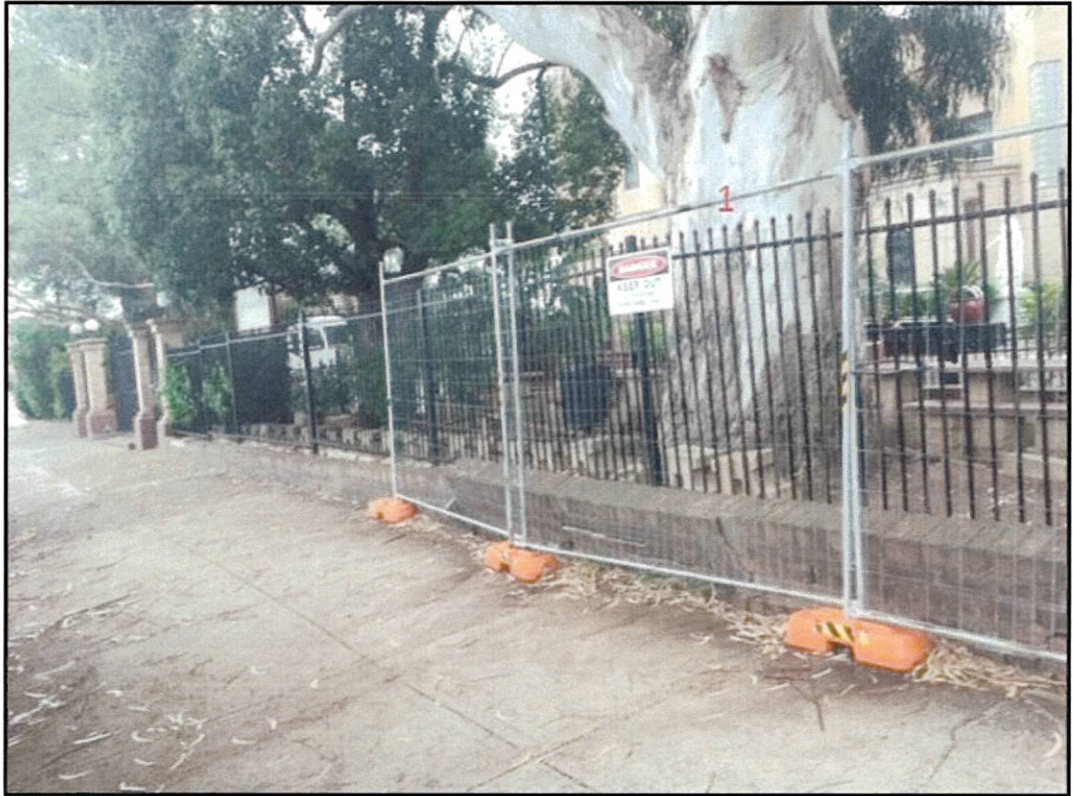
**Figure 4: Damage caused by tree no.1.**

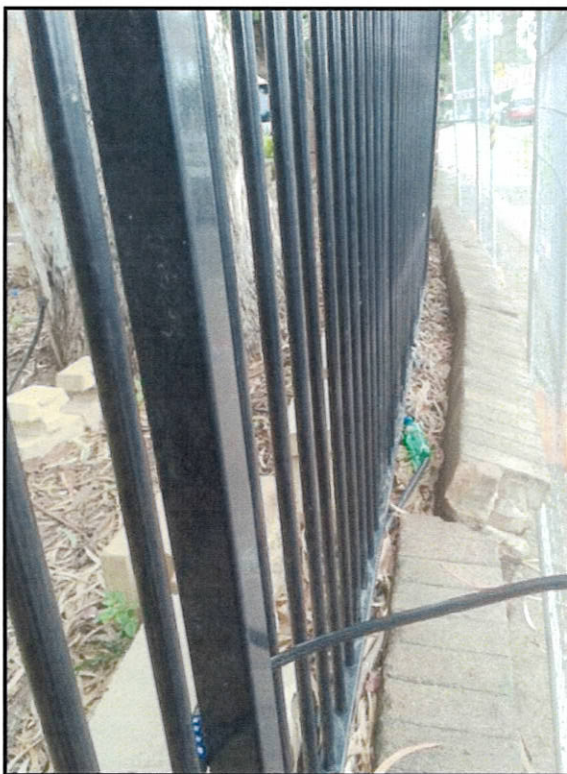
**Figure 5: Damage caused by tree no.1.**

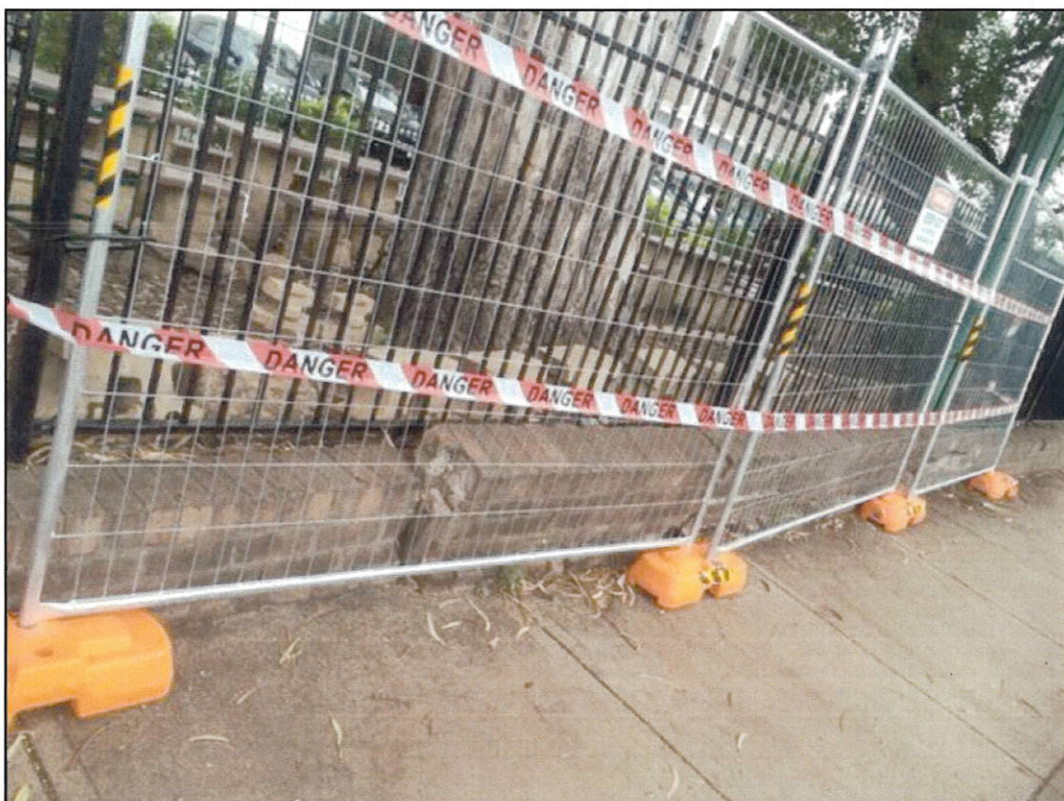
**Figure 6: Damage caused by tree no.1.**

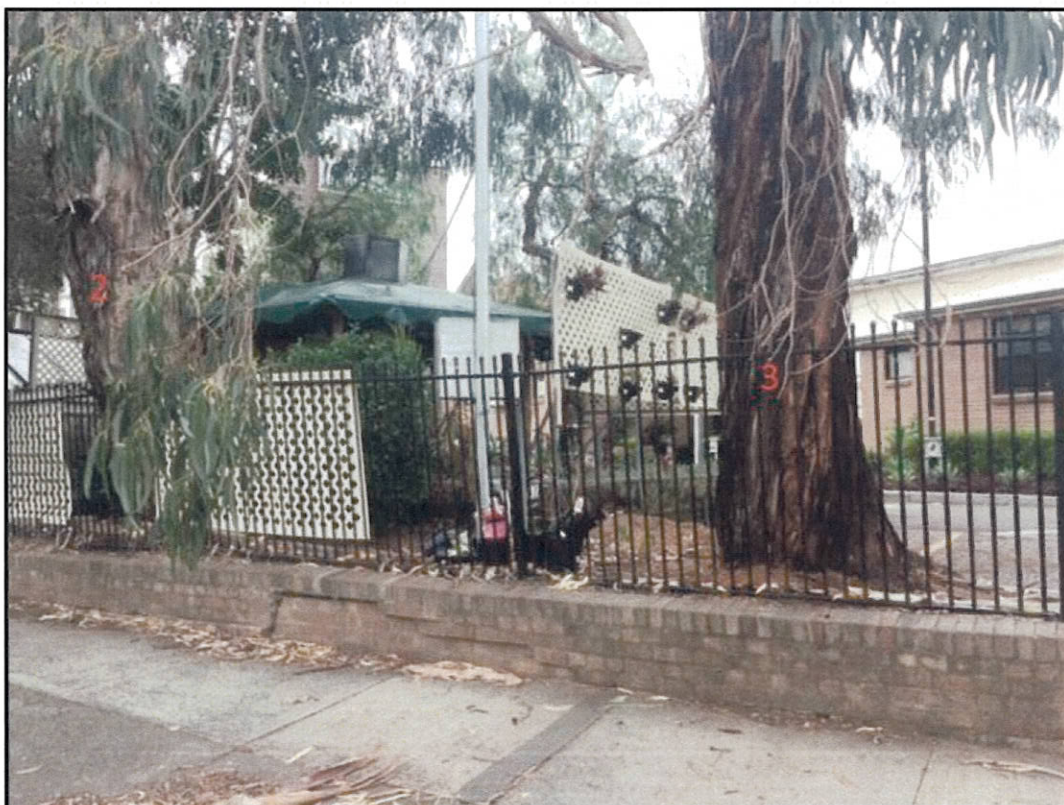
**Figure 7: Damage caused by tree no.3.**

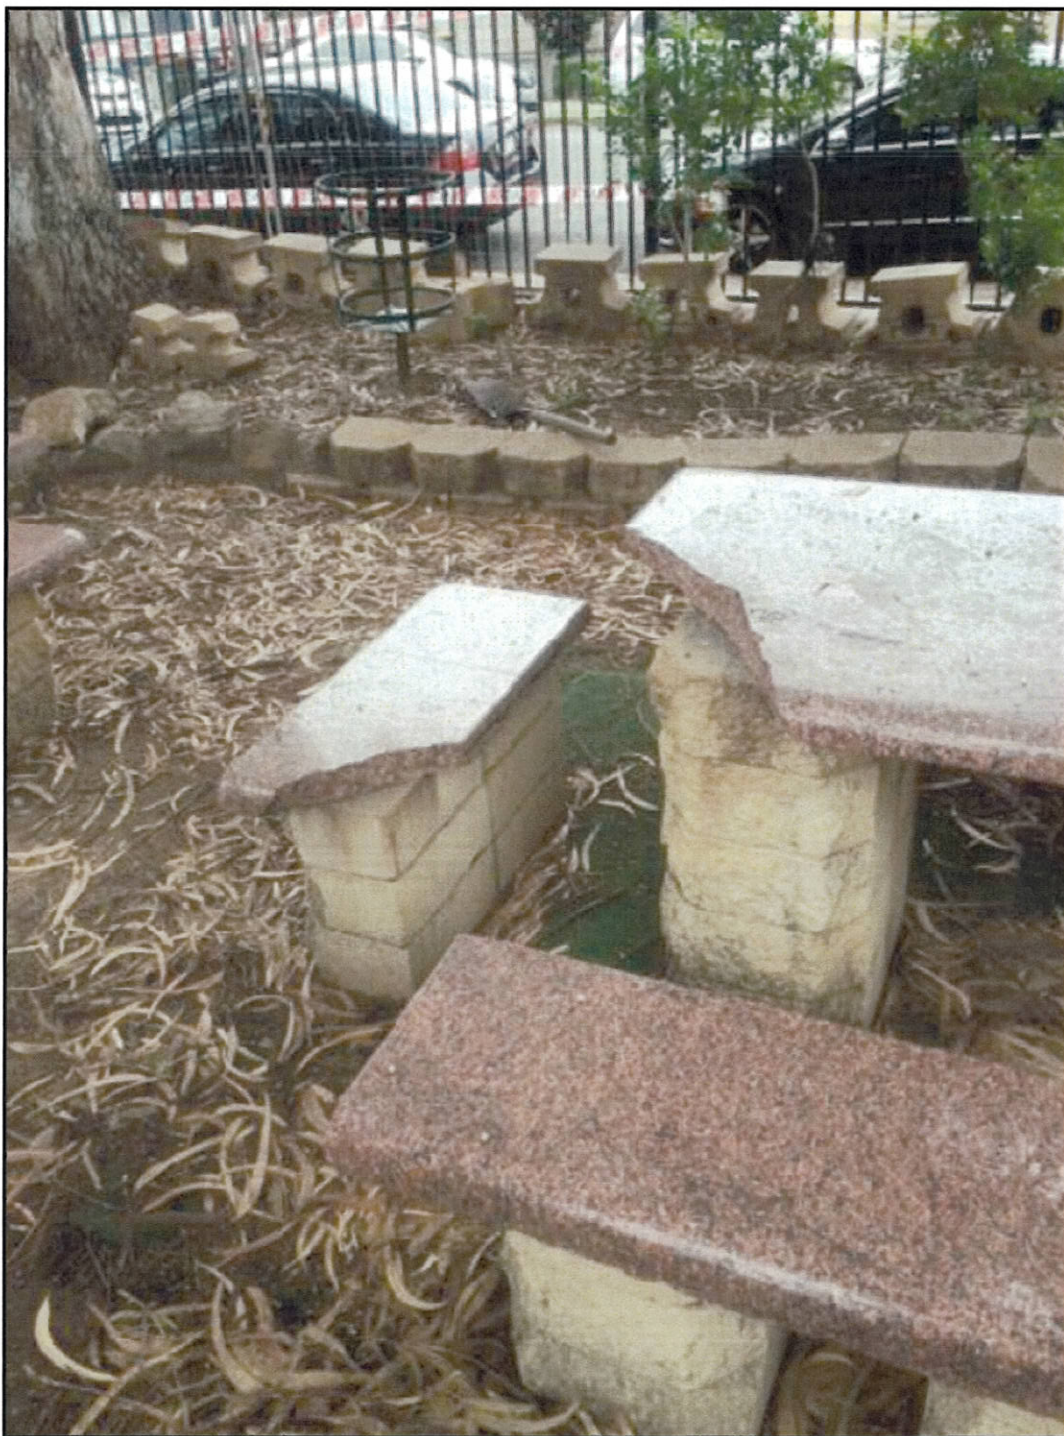
**Figure 8: Damage caused to children's play area by falling branches.**
