**Attachment K – Arboricultural
Impact Appraisal, Prepared by
Naturally Trees, dated
September 2017**

Arboricultural Impact Appraisal and Method Statement

73-75 Gardeners Road
Eastlakes, NSW

REPORT
TO
ARCHITECTUS GROUP PTY LTD
ON
GEOTECHNICAL ASSESSMENT
FOR
PLANNING PROPOSAL
AT
73 GARDENERS ROAD, EASTLAKES, NSW

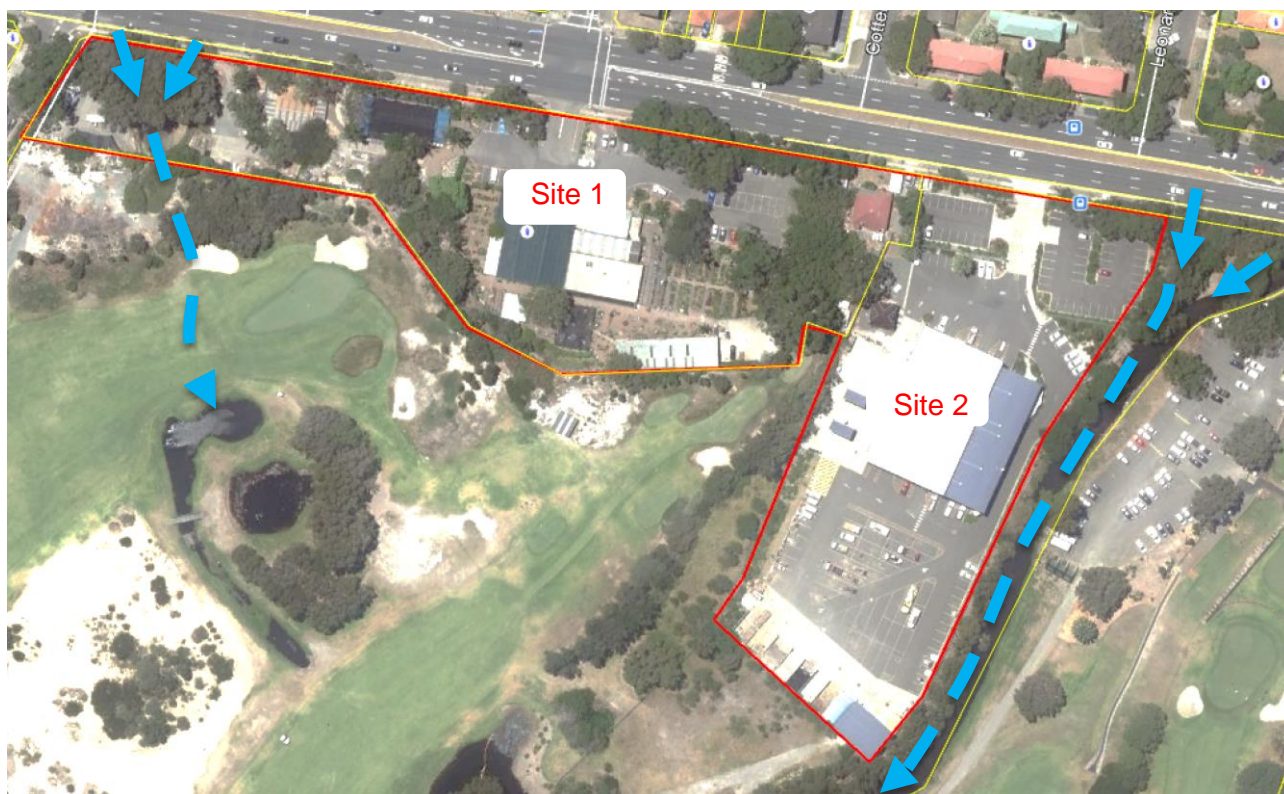
Figure 2: Existing Site Conditions

The existing depot site at 73 Gardeners Roads is mostly impervious and drains *via* multiple stormwater outlets directly into an existing Sydney Water channel which drains along the eastern boundary of the site. The stormwater channel also drains into the larger pond system within the golf course.

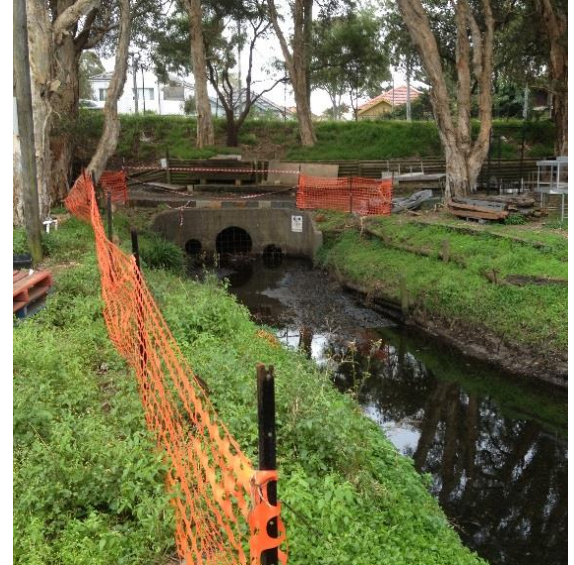
Plate 2: Western arm inflow

The assets in the western drainage channel are shown in Plates 1-4.
