# **Planning Proposal**

## **Rockdale Local Environmental Plan 2011**

## Rezoning of land at 119 Barton Street, Monterey to R3, Medium Residential Density

August 2017

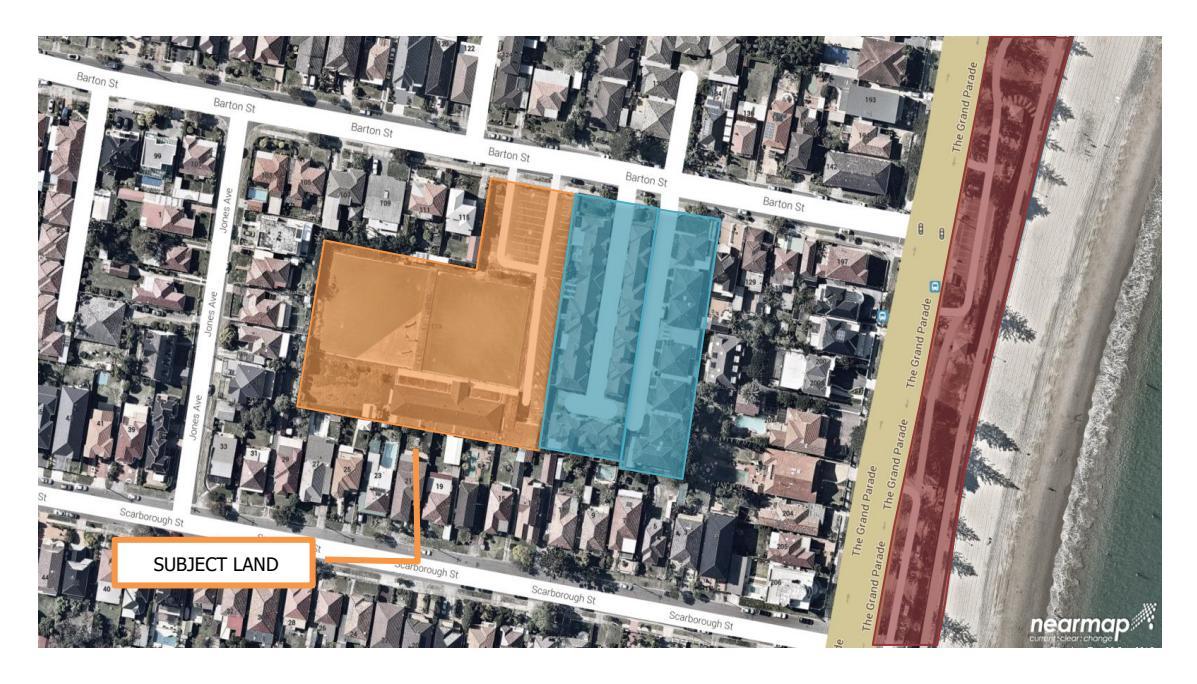
The subject land, comprising the former Francis Drake Bowling Club, is a large battle axe lot known as 119 Barton Street, Monterey. It has the legal description of Lot 2 DP 857520. With a northern frontage of approximately 35 metres to Barton Street, the site has an eastern (side) boundary shared with the part one- part two-storey 'Oak Flats' townhouse development at 121 Barton Street. The irregular western (side) boundary measures approximately 155 metres and adjoins the rear yards of residential development at Nos. 107-115 Barton Street and Nos. 2-10 Jones Avenue. The southern (rear) boundary, approximately 95 metres in length, abuts the rear yards of residential development at 13-29 Scarborough Street. The total area of the site is approximately 7,218 sqm. The location and context of the site are shown in the aerial photograph below.

Subject land, 119 Barton Street Cook Park, The Grand Parade (I168) Adjoining medium-density residential development

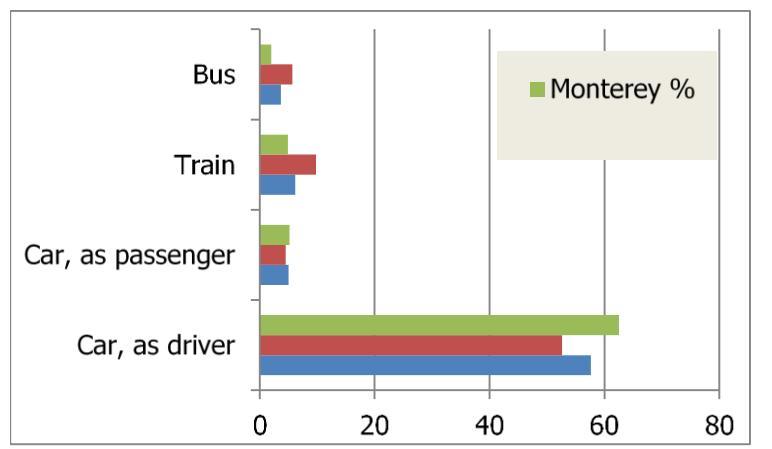
Figure 3: Comparison of journey to work modal split – Monterey, Metro Sydney and NSW

At the 2011 Census, the most common method of travel to work for employed residents of Monterey was by car, 62.5% as driver and 5.2% as passenger. The location of bus and train services, as discussed above, is not reflected in greater usage by Monterey residents of bus services in combination with train services compared with Metropolitan Sydney as a whole (refer figure 3 below). 15.5% of employed people in Monterey travelled to work on public transport compared with 21.4% across the Sydney region.

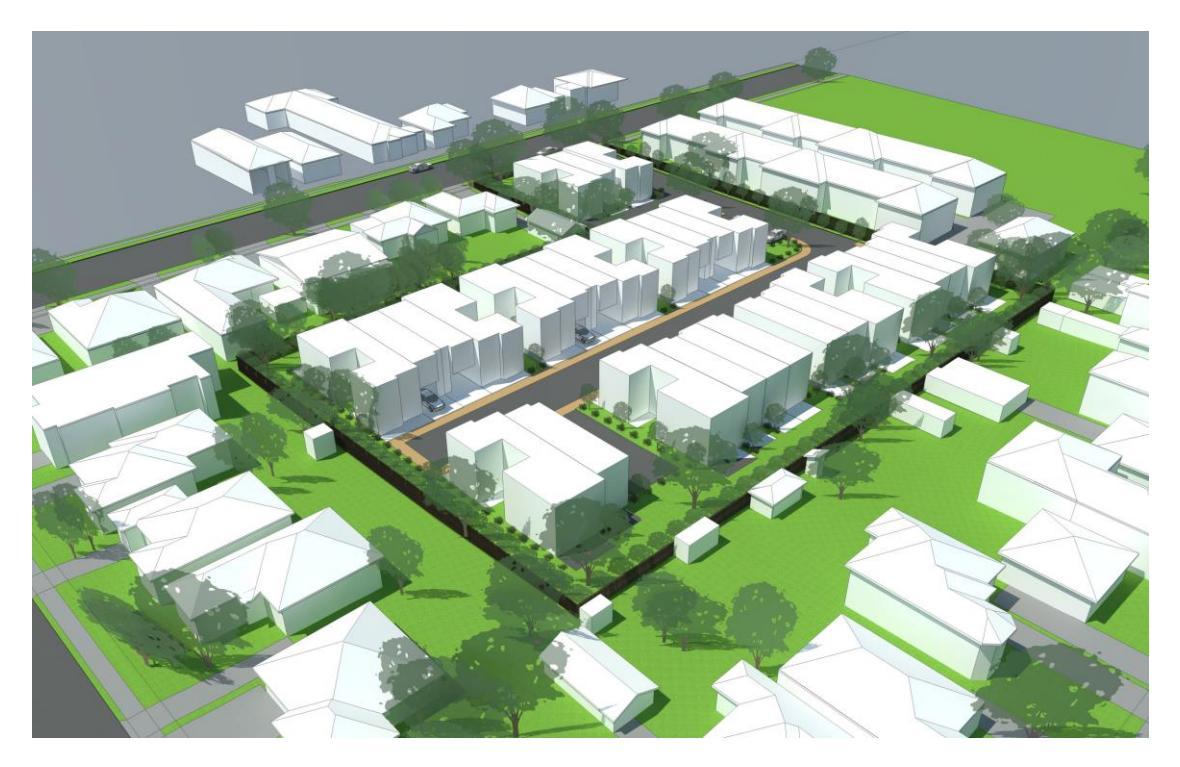
Figure 10 – 3D study model, looking south – north

An analytical study conducted by Rothelowman has produced a model for development yield and building typology. This concept illustrates the capacity of the subject site to accommodate 28 two and three-bedroom townhouses, as shown in Figures 10 and 11 below.

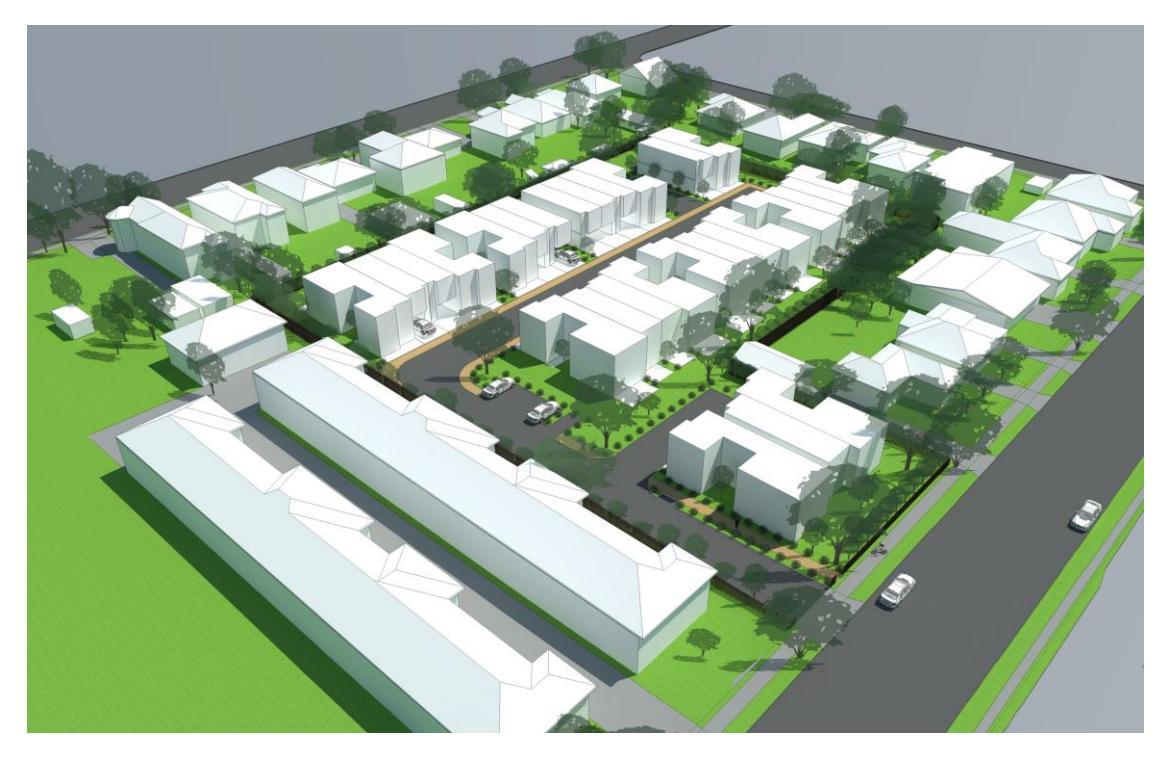
Figure 11 - 3D study model, looking north – south

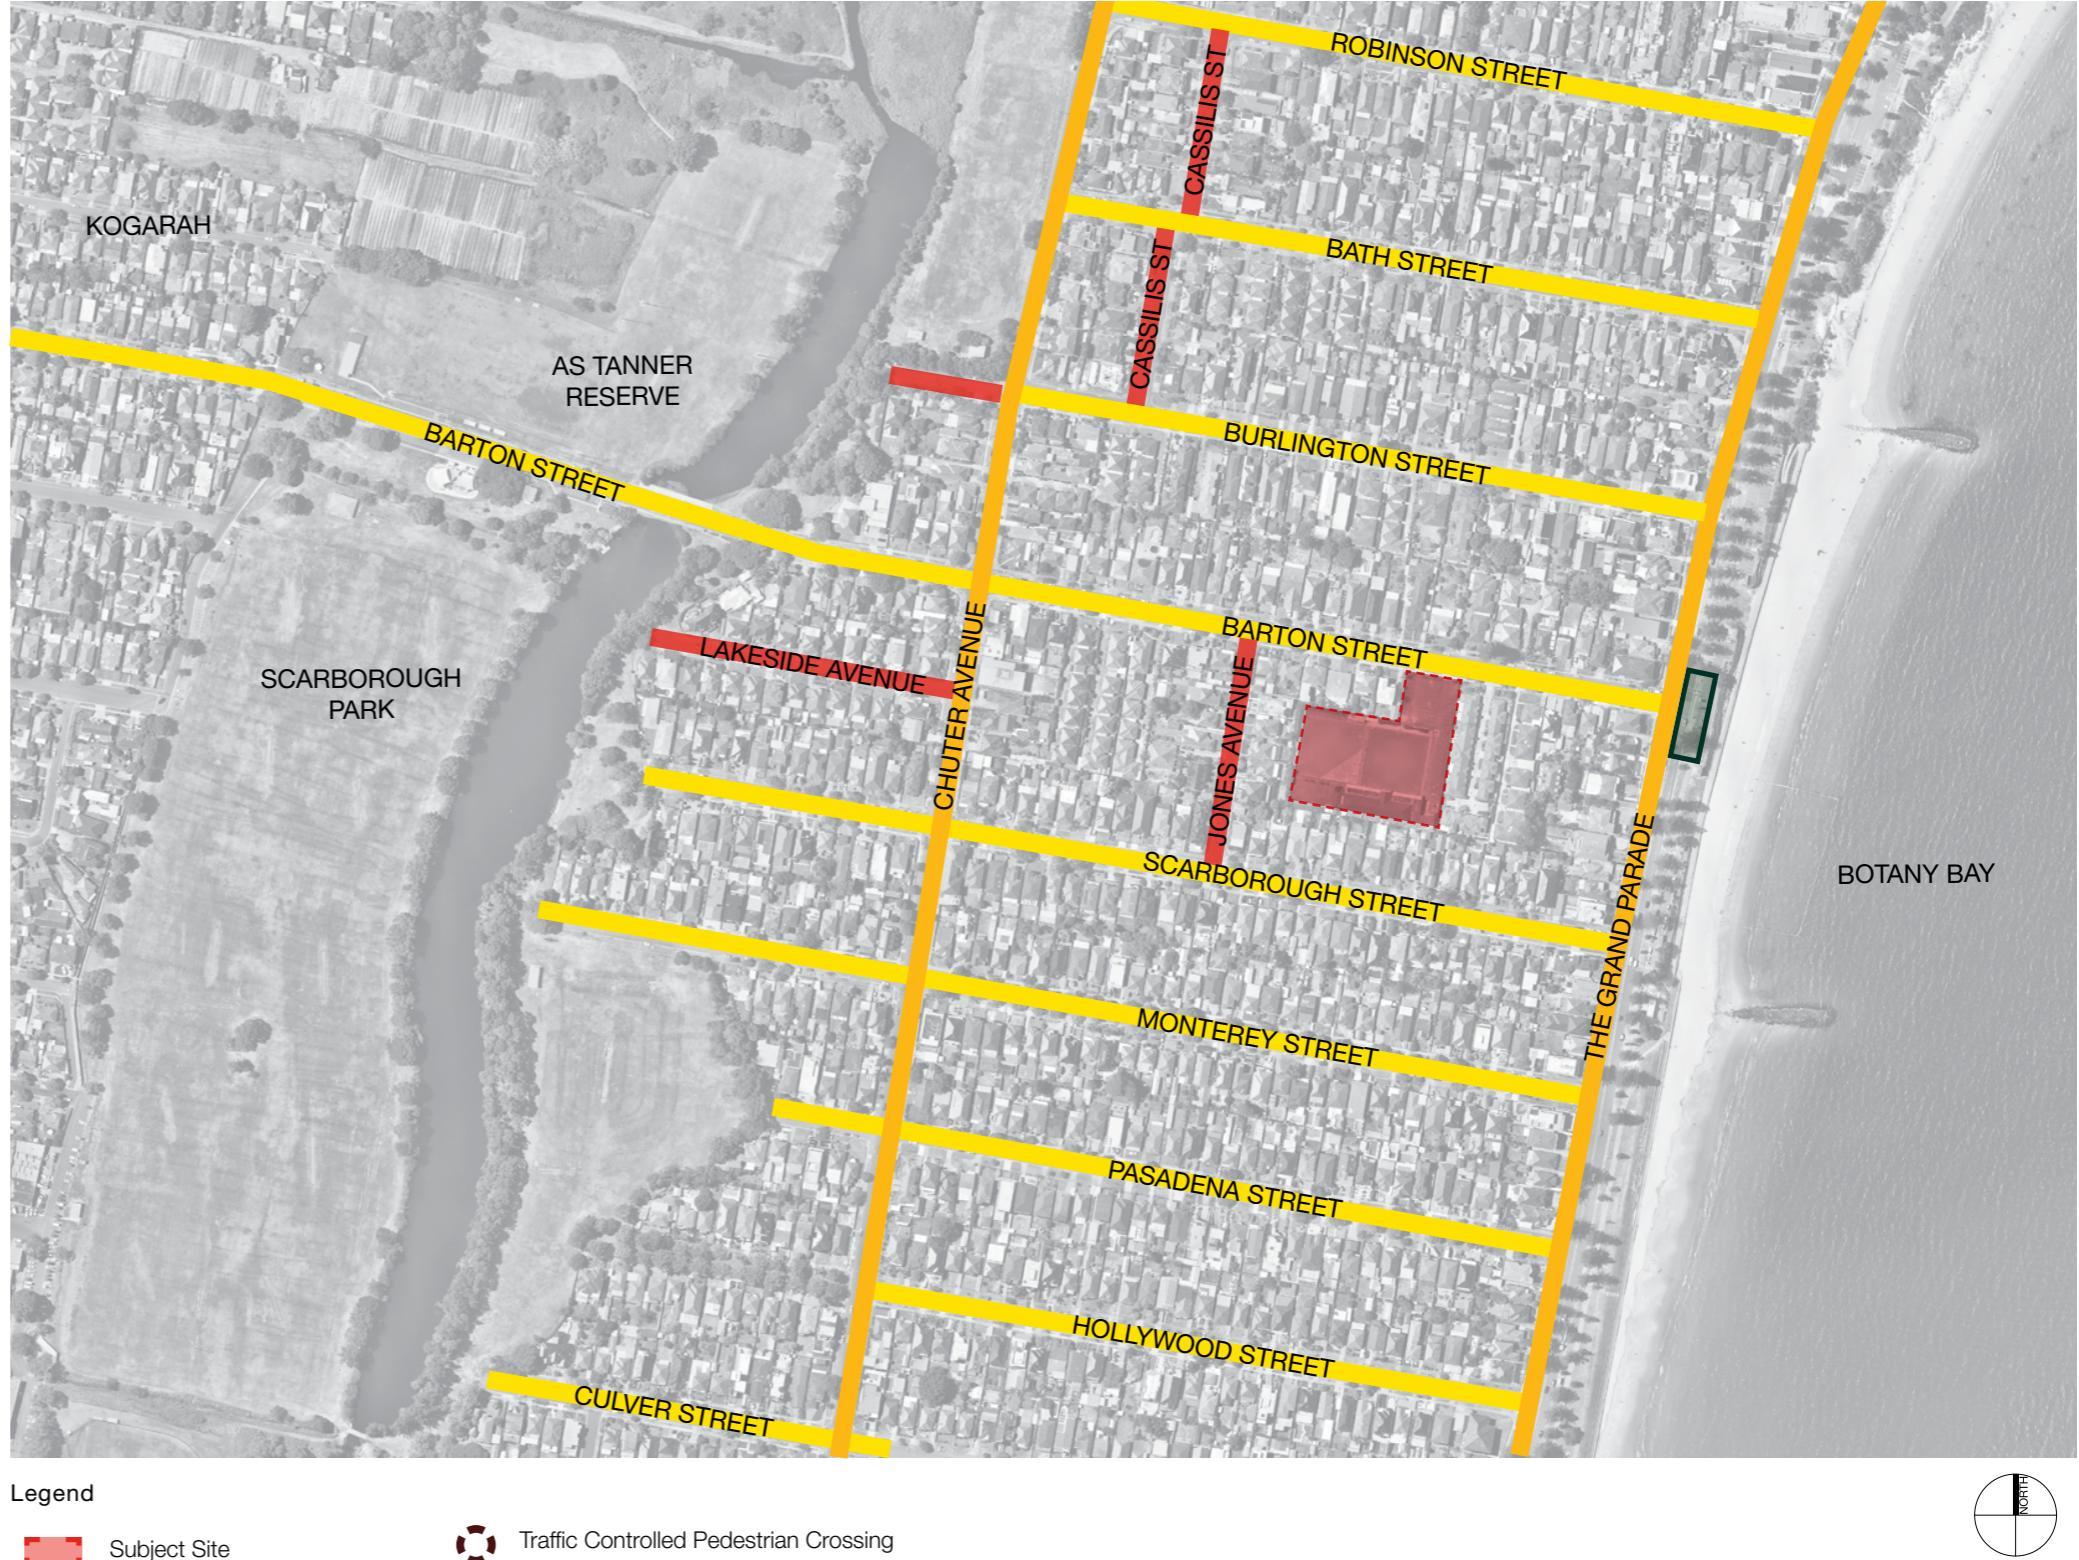
## 2.0 Urban Context Site Analysis 2.02 Site Context & Vehicular Network

The East-West streets service mainly the local community

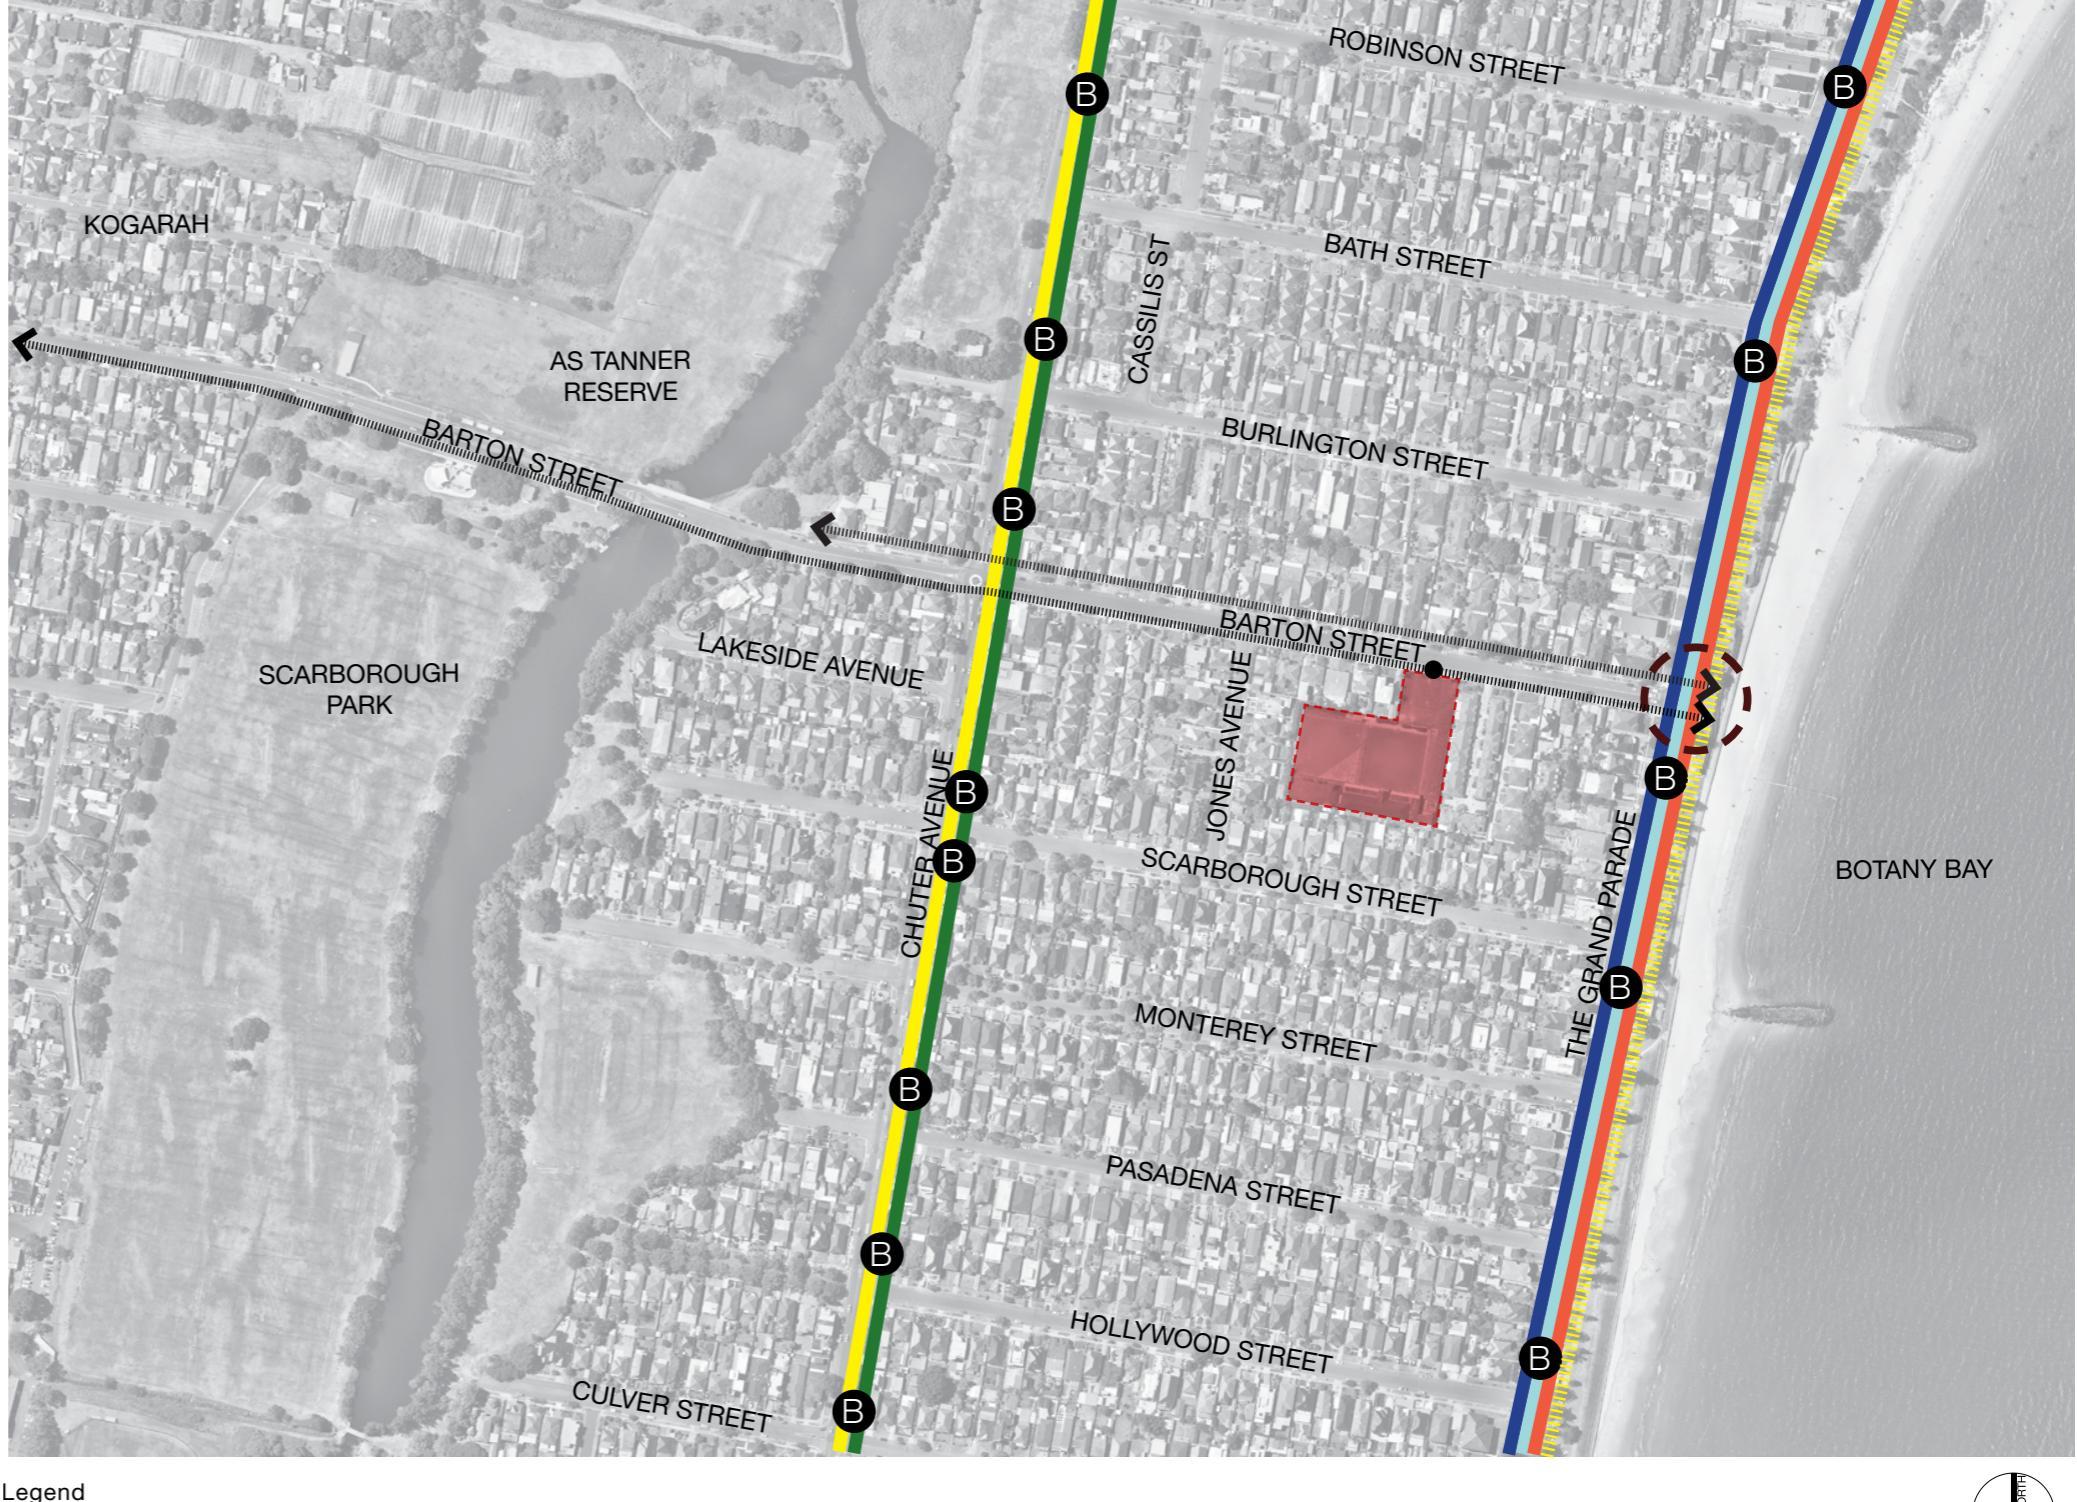
## 2.0 Urban Context Site Analysis 2.03 Public Transport & Pedestrian Movement

Buses operate along both The Grand Parade and Chuter Avenue

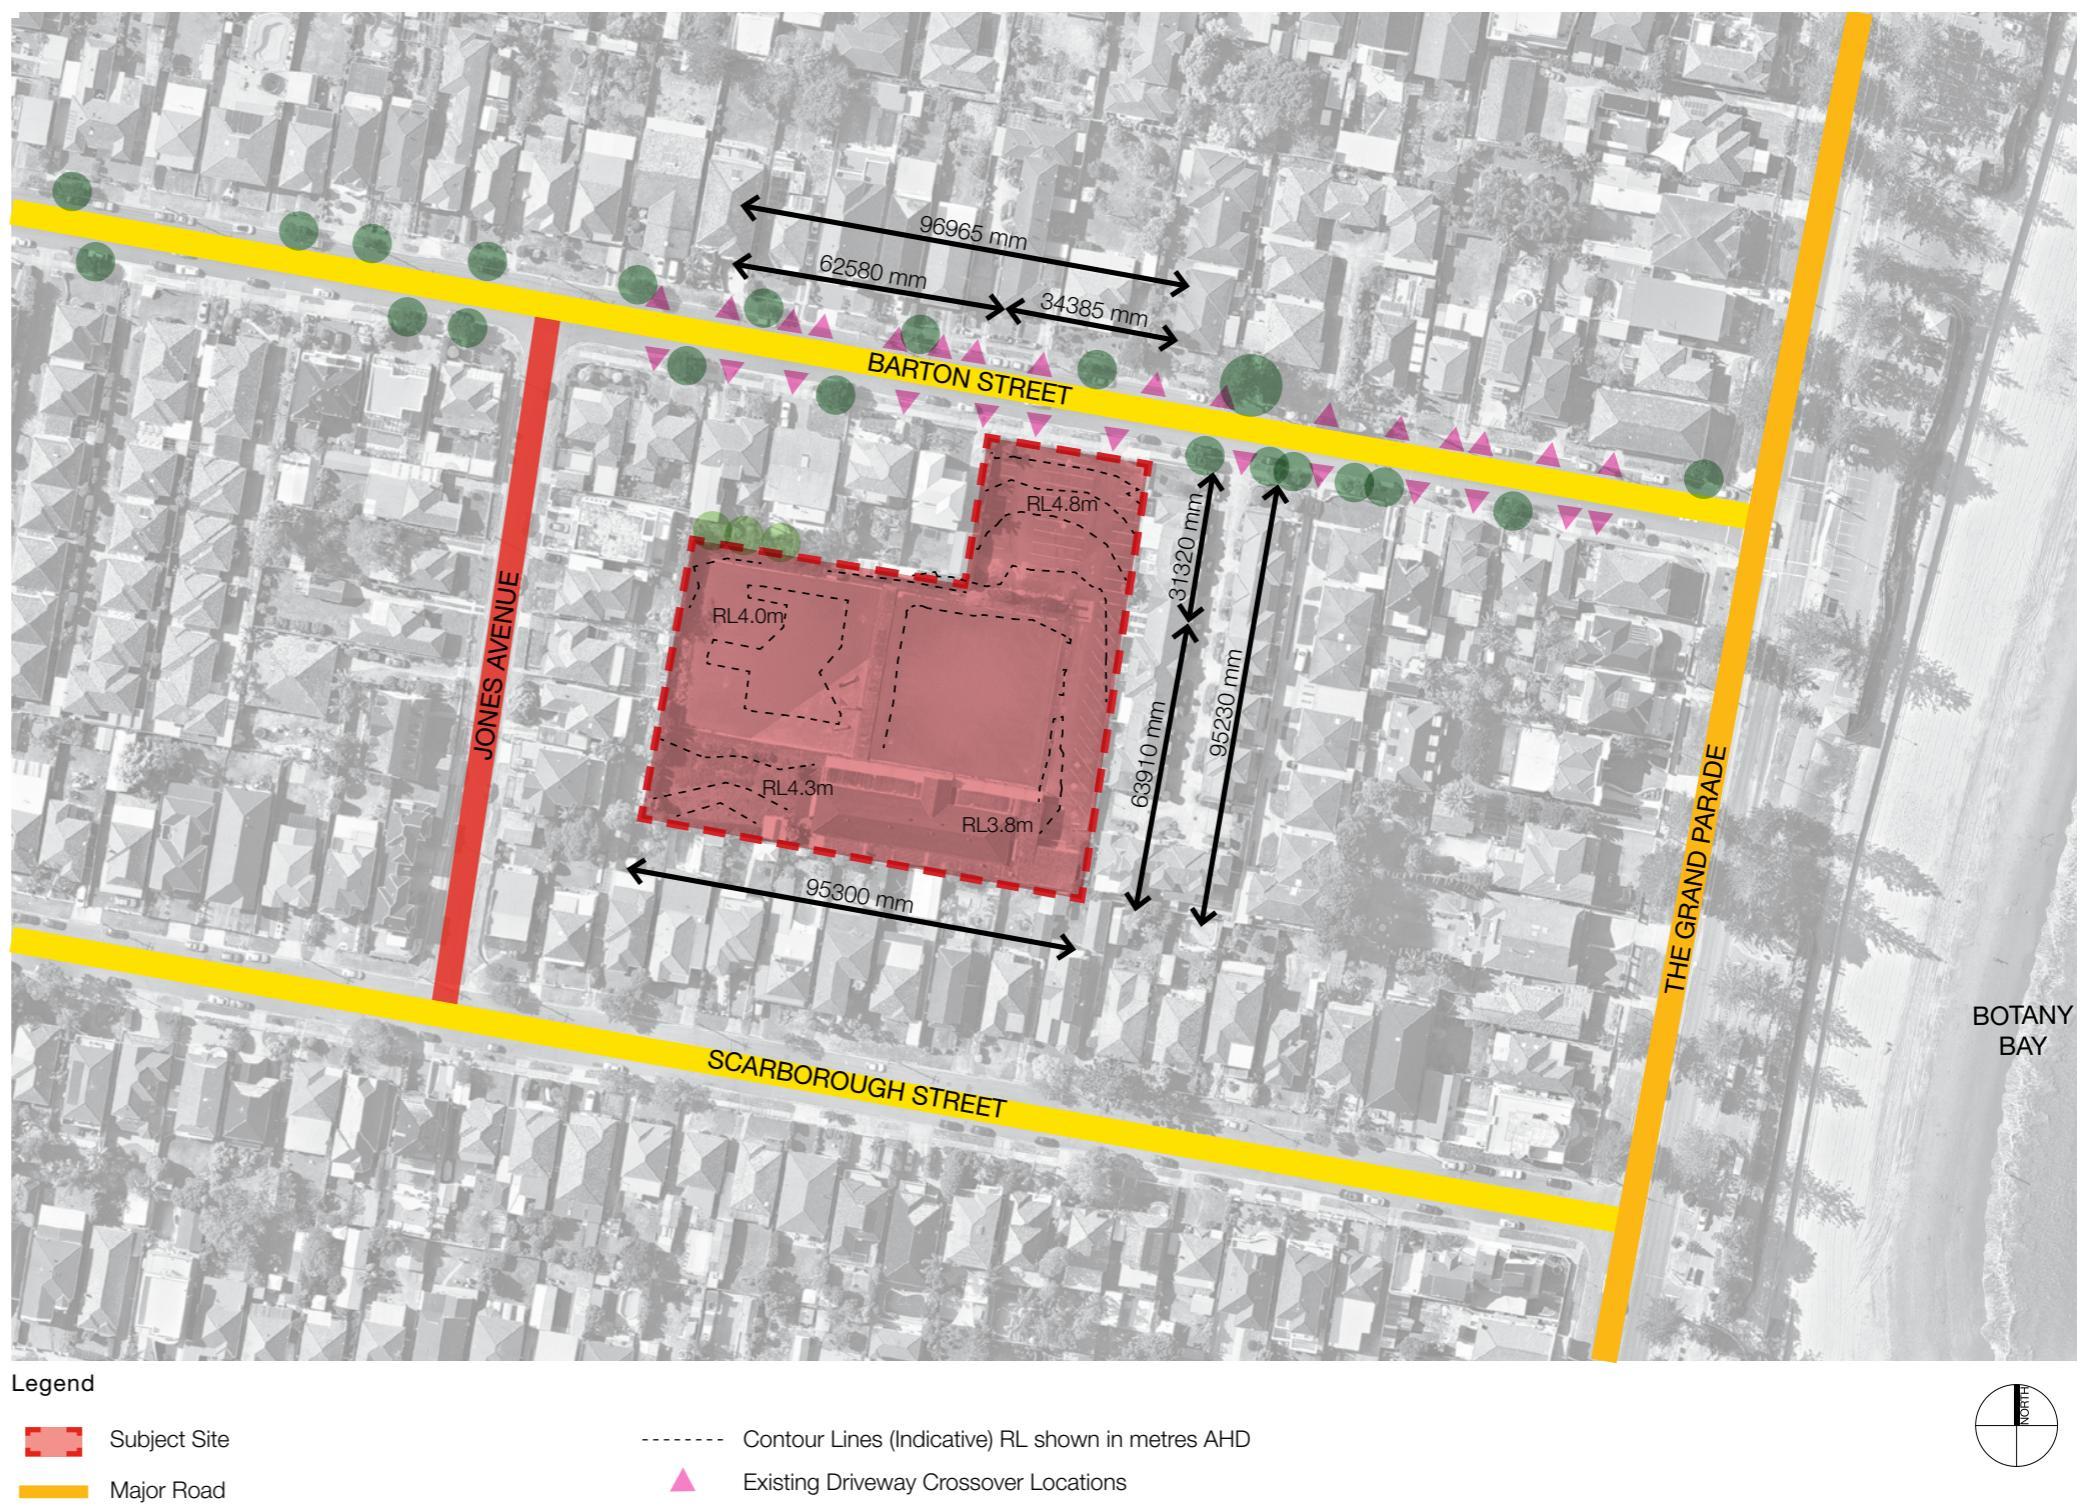
## 2.0 Urban Context Site Analysis 2.06 Streetscape Context

The existing streetscape is still very much a low rise, low density residential typology.

The Street is punctuated with driveways accessing individual properties and there are a few sporadically placed street trees. There is no consistency of planting across the immediate context.

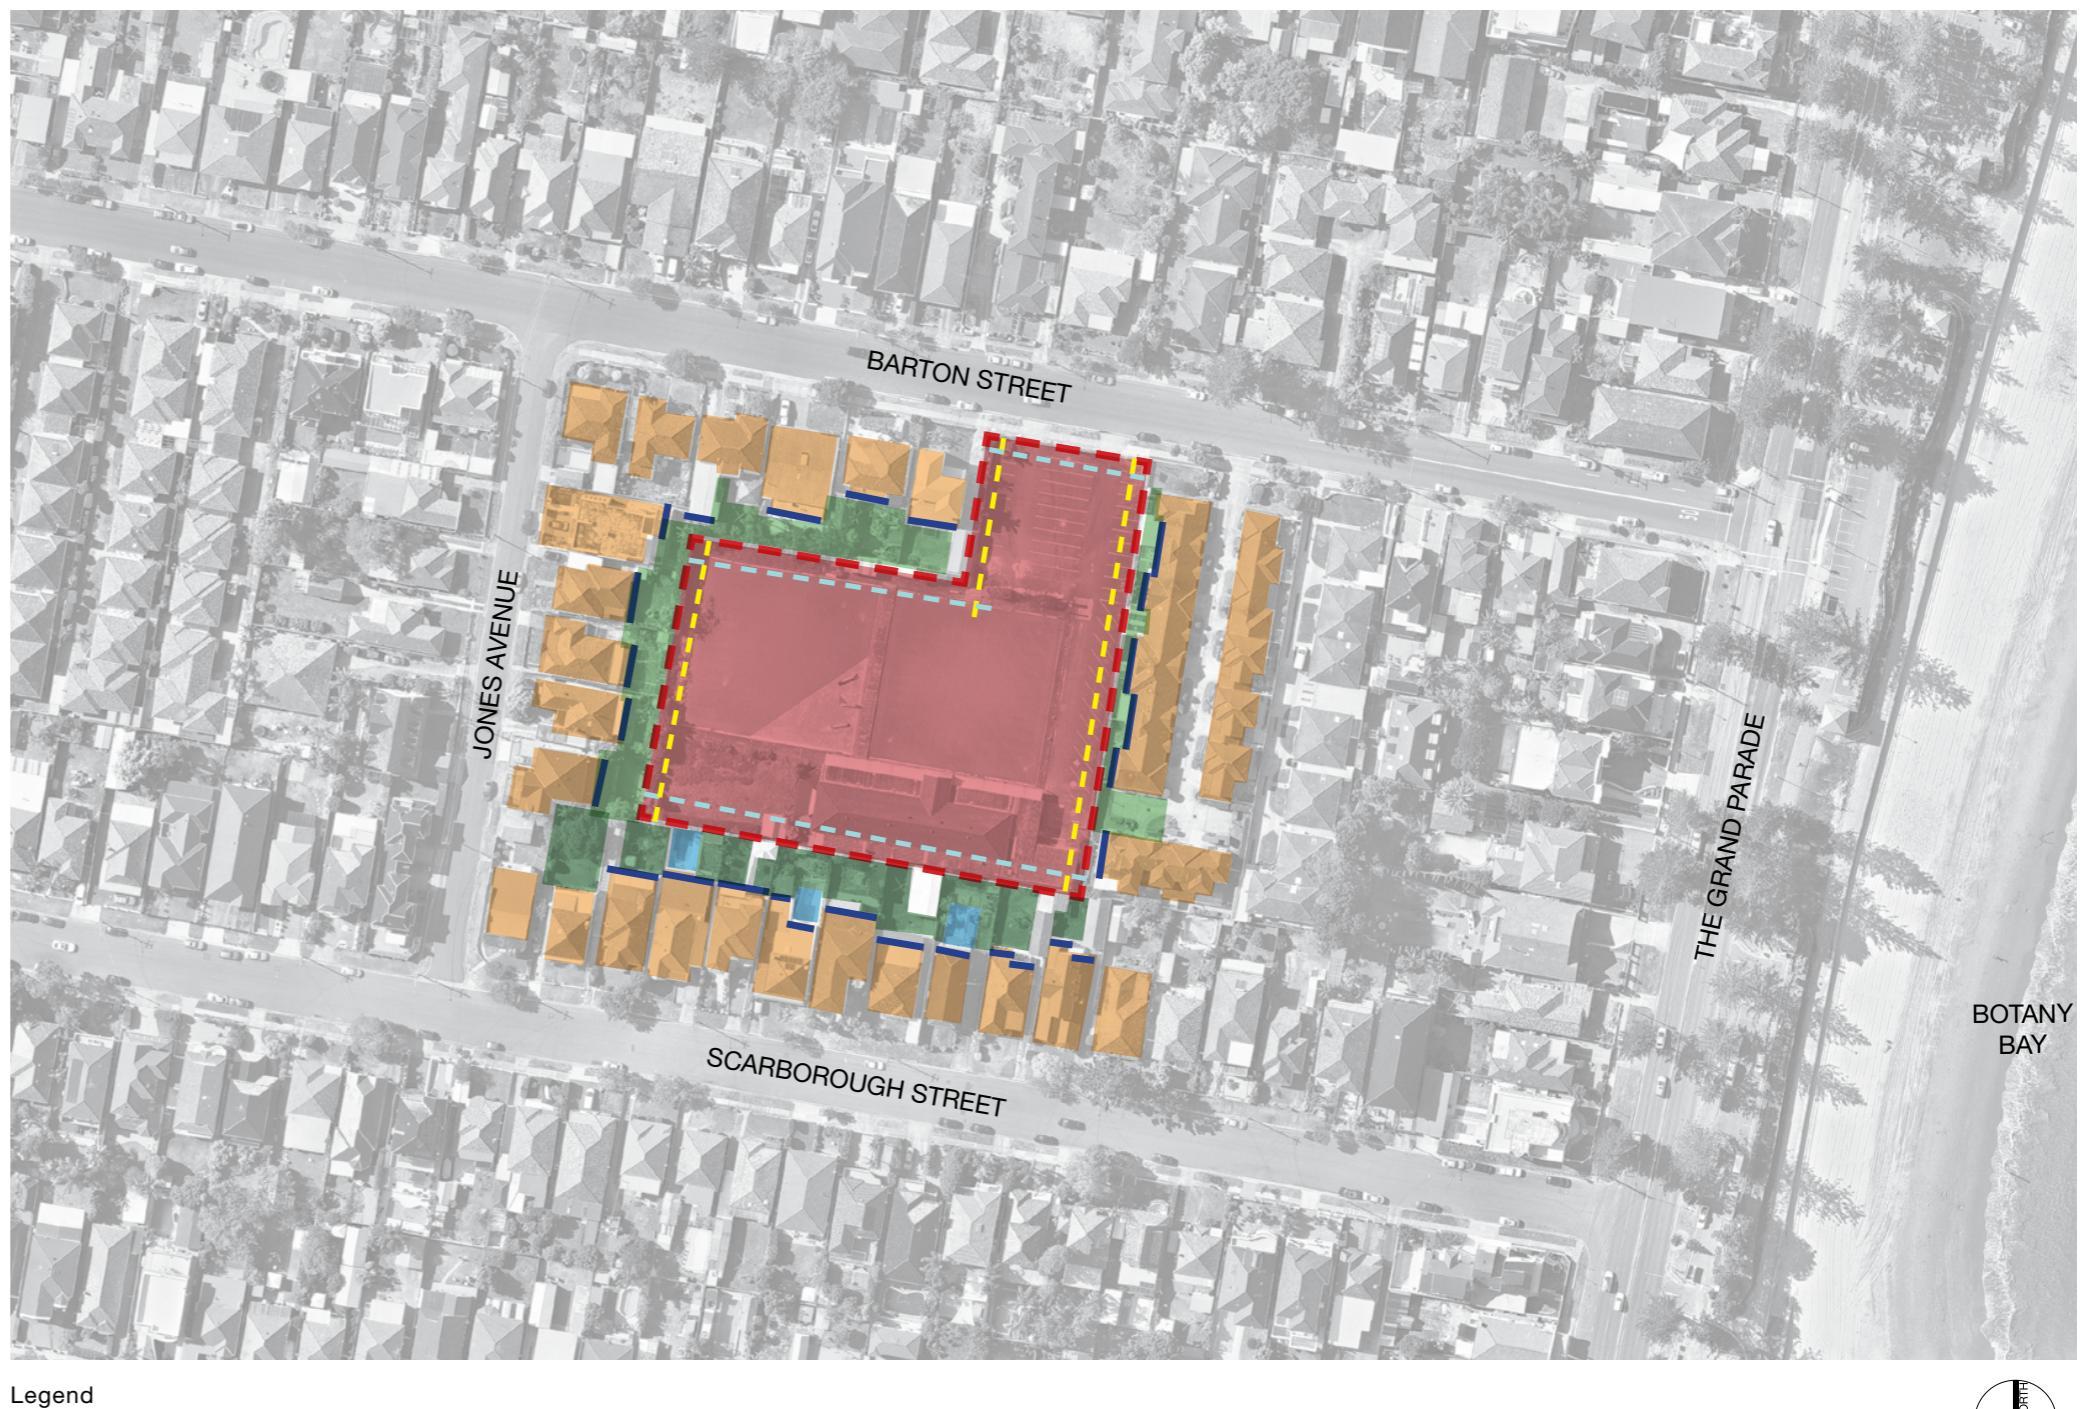
## 2.0 Urban Context Site Analysis 2.07 Site Constraints Analysis

There is a gradual fall across the site from Barton Street to the south-east corner of the site. The remainder of the site is relatively flat.

The site sits in a well-established neighbourhood with limited examples of multi unit- subdivision.

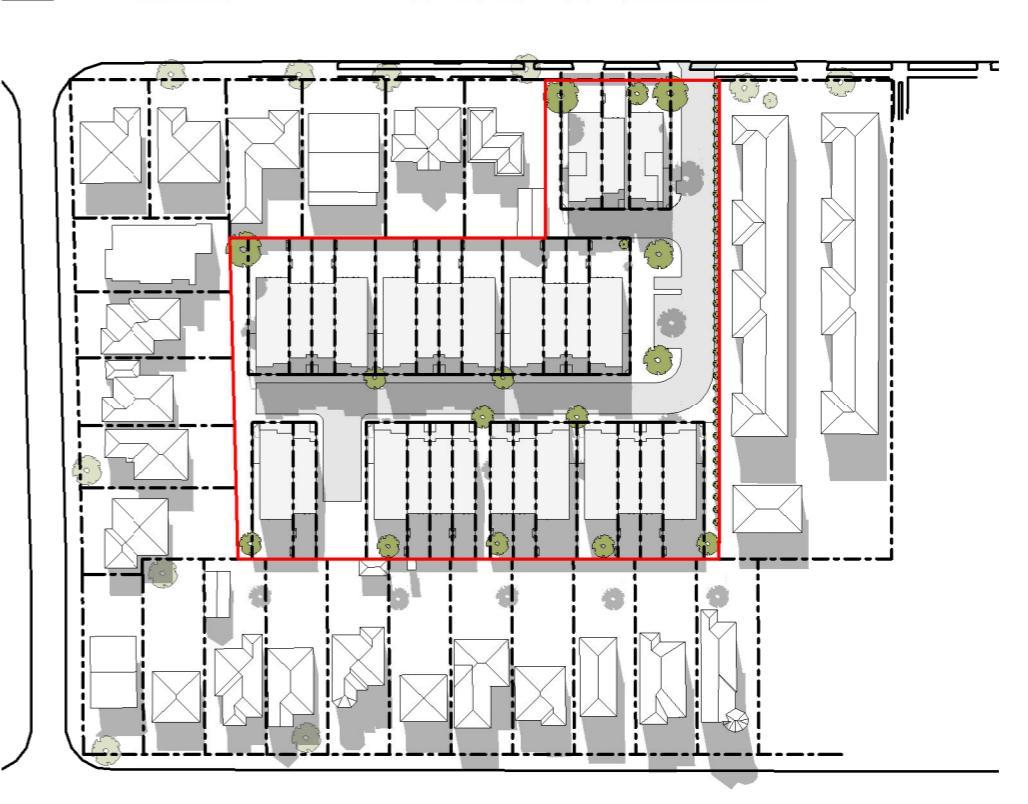
21 JUNE 12pm - SOLAR ANALYSIS
